# GLOBAL TECHNICAL BULLETIN

Ref No.: GTB2009016  
Date: September 16, 2009

**To: All Yanmar Marine Distributors**  
**Subject: Oil level change for SD50 series**

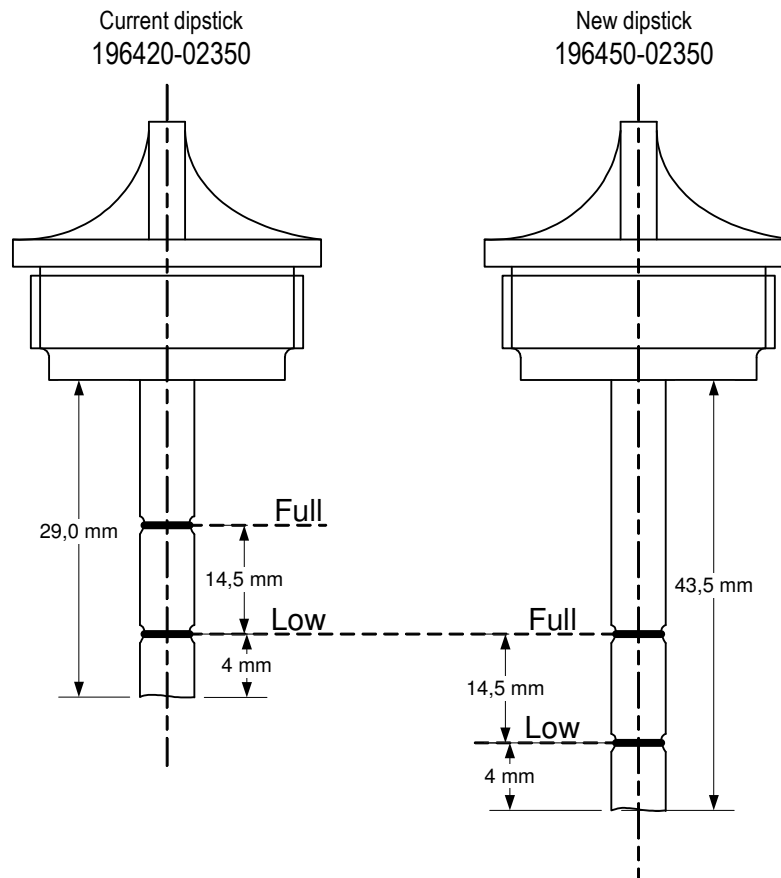
In order to obtain a lower oil pressure inside the drive, the maximum oil level has been changed from full position to low position on the dipstick.

[The difference is 14.5 mm on the dipstick]

The part number of the dipstick of the SD50 series has been changed from 196420-02350 to 196450-02350

- Please check the oil-level in the SD50 during regular maintenance.
- Correct the oil-level in the SD50 according to above specifications. If above newly recommended level; please remove oil to make the adjustment.
- If the oil-seal from the input-shaft or propeller-shaft is still leaking after correction of the oil-level, please replace the oil-seal.

**Remarks:** Dipstick is very short, so no possibility to put new low-level mark on current dipstick. Please use current low-level mark as new high-level mark for correct oil-level.
